FINAL REPORT, STUDY OF THE EFFECTS OF FUEL VORTEX
FILM COOLING ON HIGH TEMPERATURE COATING DURABILITY

BELL MODEL 8701

REPORT NUMBER 8701-910045

JULY 1974

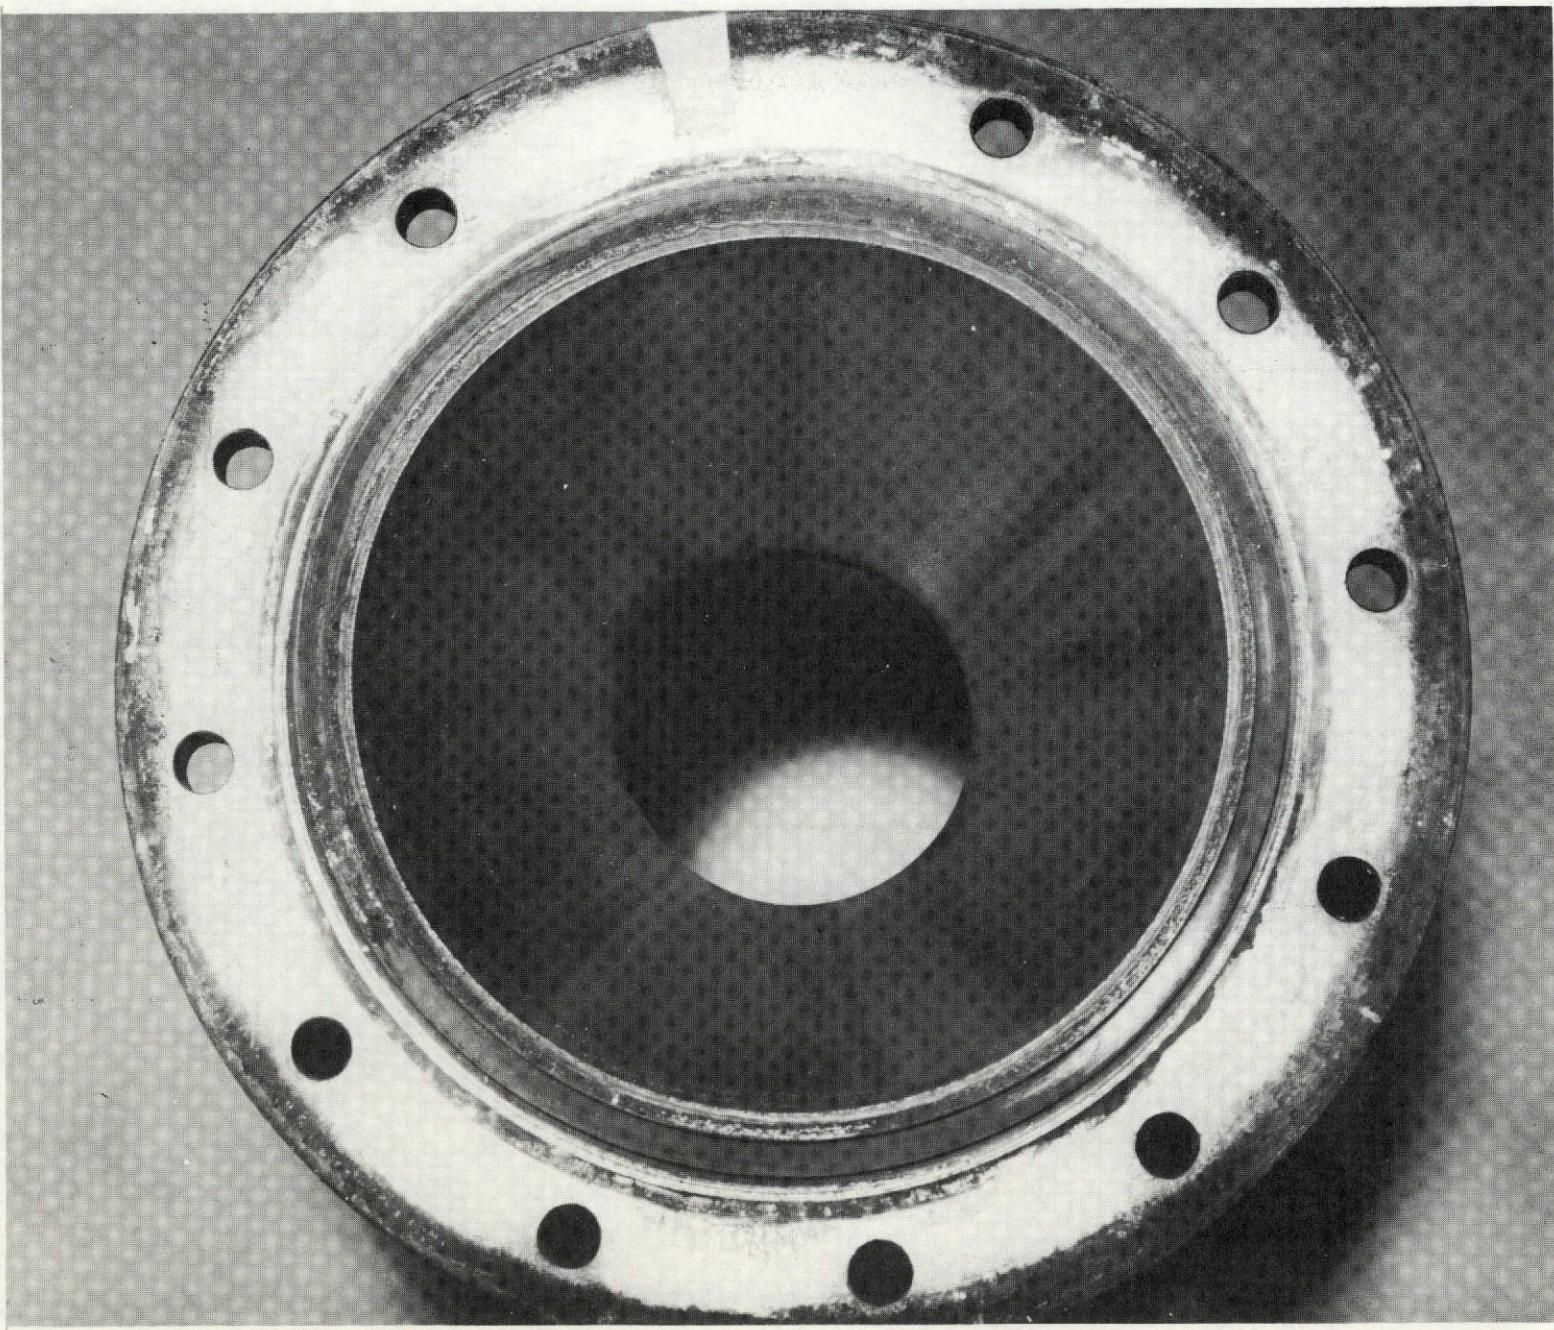
FIGURE 3.3-1. POST TEST B-1-1204. INJ. S/N FT-1C T.C. S/N FS 85-P1
(VIEW FROM NOZZLE END)

The injector was cold flowed prior to initiation of hot fire testing. The results indicated acceptable injector pattern with a fuel barrier flow rate of 13.8% (% total flow). A baseline test was conducted and then the worst case missions (as defined on the basic Technology Program) conducted. A minor anomaly occurred during the test program. After the seventh 95-sec. test of MDC #2 the test valve would not close due to a faulty actuation valve and the test was terminated at this point by closing the test stand valve. Replacement of the actuation valve corrected the situation. MDC's 5 and 6 were modifications of the worst case mission and were conducted at maximum operating conditions (max P_c , O/F, T_p). MDC's 7 - 15 were 60-seconds continuous firings each. Post test evaluation indicated the hardware to be in excellent condition.

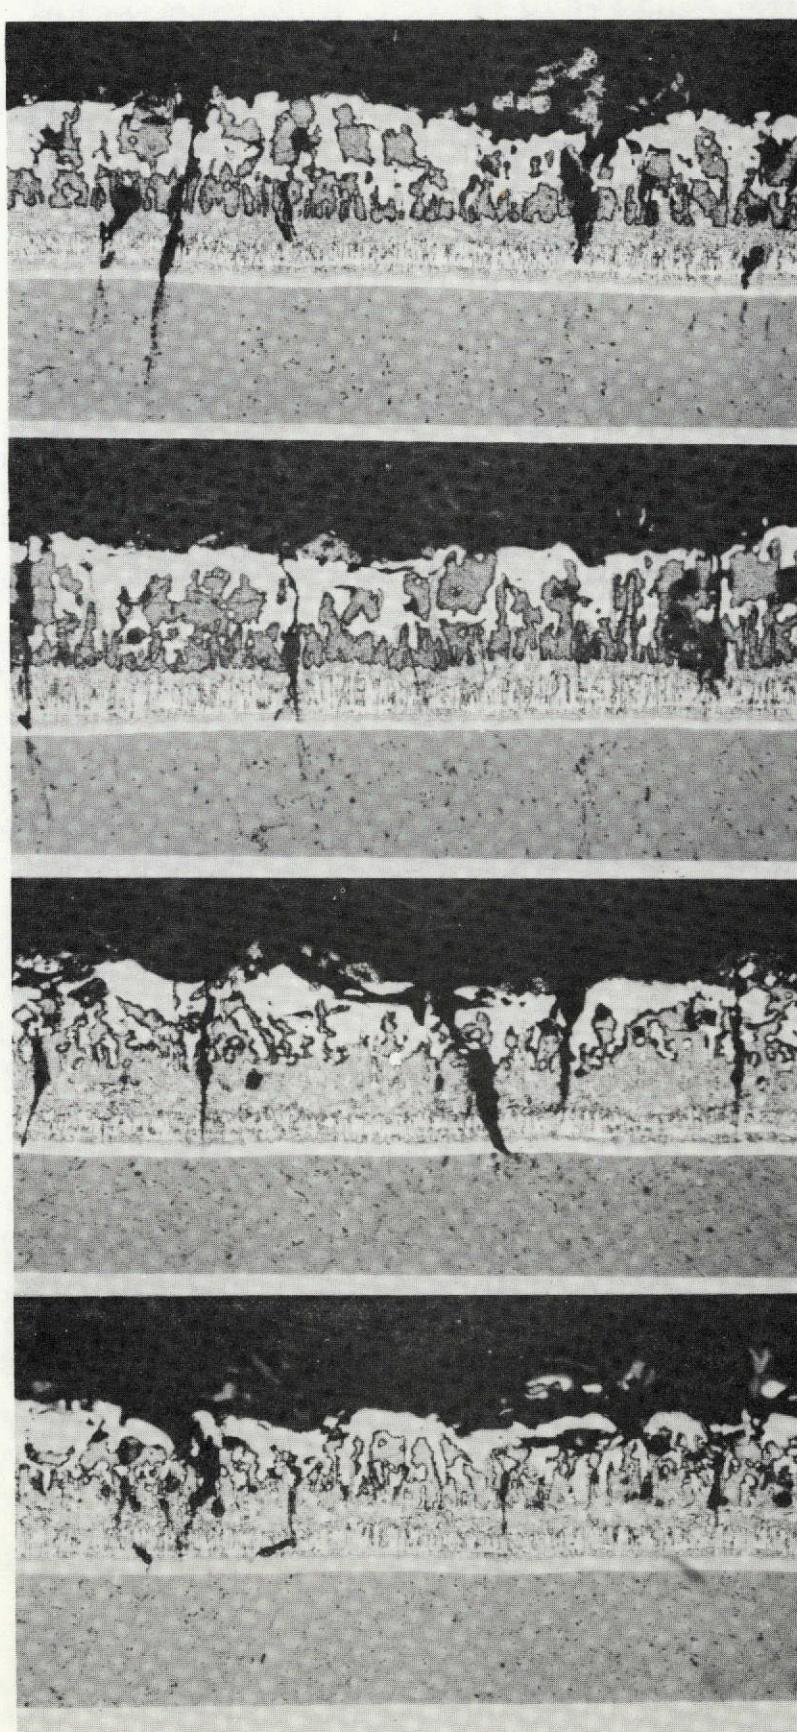
**FIGURE 3.4-8. PHOTOMICROGRAPHS SHOWING R512E COATING CONDITION IN
VARIOUS LOCATIONS OF CHAMBER FS-85-P1**

Figure 3.4-8 shows photomicrographs of the coated FS-85 thrust chamber at the four locations indicating the coating to be in excellent condition. As expected, there was no significant difference in coating thickness or constituents in the four locations. The outer silicide layer has remained intact on all samples including the throat region. The mid thickness complex silicide remained intact and continuous. No instances of complete separation or pull-out of the coating occurred. The microcracks (characteristic in sectioned samples) in the coating were tight extending down to or into the inner silicide diffusion zone. These were not oxidized or altered and many are generated during sectioning/polishing of the samples. There was no visible evidence of oxidation, nitriding or other degrading effect from the firing.

a) Sample #1
Close to
injector.

Coating thickness:
0.0045"
